## Mini Combi A3, A6, B8 & B10 Repair Procedures

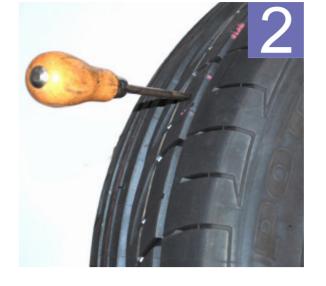
Locate the injury. It should be within the edges of the stabilliser belt on the crown or tread area of the tyre.

For exact repairability and dimensions, please use the Mini Combi Repair Chart.

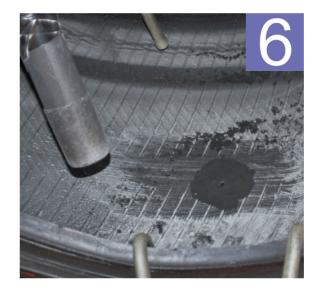
Use a fine grit contour wheel. Carefully buff the liner, ensuring it is NOT buffed all the way through. Over-buffing can cause future air loss and the repair will ultimately fail.

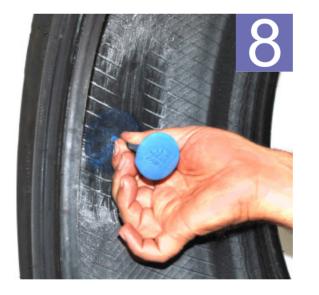
Using a 12g tube of Special

Cement, apply cement into the puncture channel. Using a 225g can of Special Cement and the supplied brush, apply cement to the prepared area. least 10 minutes before introducing the Mini Combi Insert needle to the prepared puncture channel.

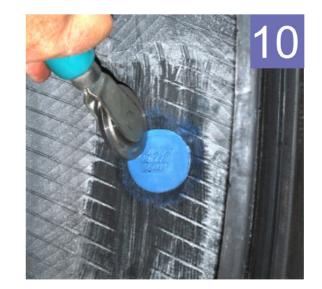
Pull the insert needle of the Mini Combi towards the outside of the tyre using pliers until the patch has seated on the cemented area.

Ensure there is no dimple in the seated patch as this may weaken the repair.
